A Machine Learning Approach for Automated Detection and Classification of Cracks in Ancient Monuments using Image Processing Techniques

Ramani Perumal^{1,*}, Subbiah Bharathi Venkatachalam²

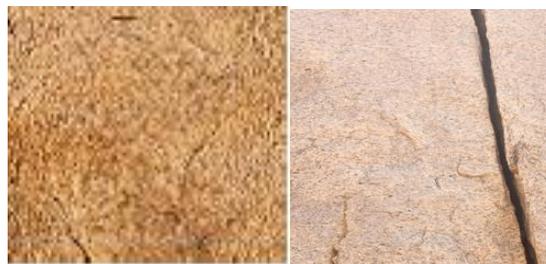
Figure. 1. Ancient Monument Images (a) Normal (b) with Cracks

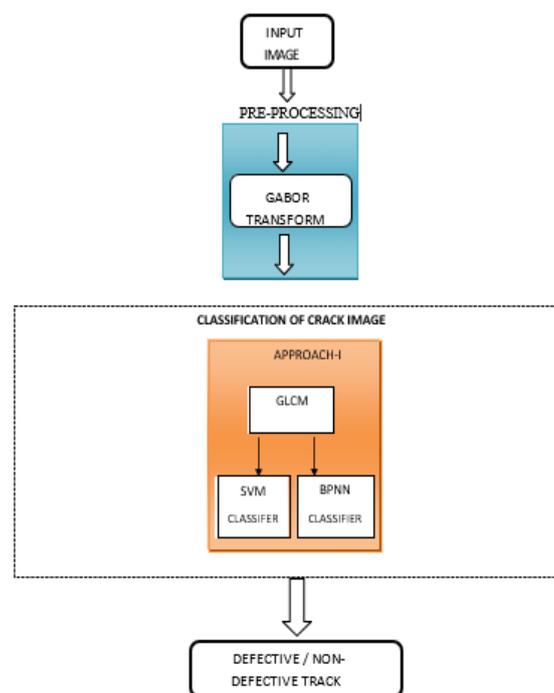
Figure. 2 Proposed Crack Detection System

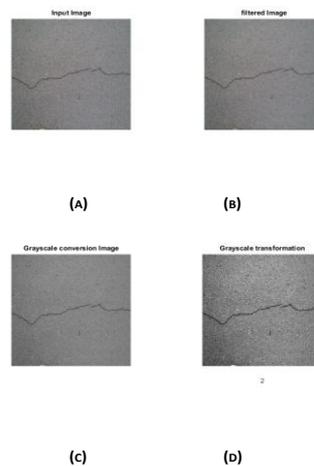
Figure. 3. (a) Image with Crack (b) Pre-processed Image of (a), (c) grey scale transformation, (d) Pre-processed Image of grey scale.

It enhances the image, allowing the hole to be more easily seen. The captured image is then converted to monochrome form. An Adaptive Histogram Equalization (AHE) technique was used to smooth out the damage in the image. This is achieved by boosting the image's contrast, which converts the image's colour value to an intensity value

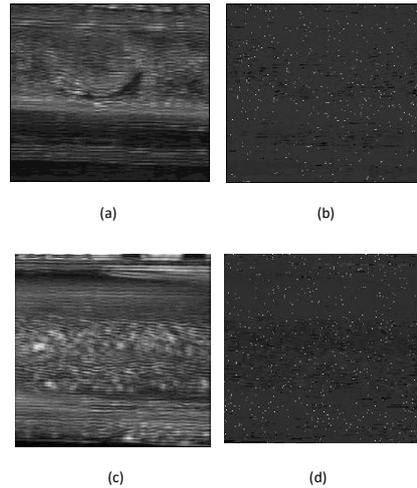
Figure. 4. (a) and (c) Gabor Magnitude Image with Crack and Without Crack (b) and (d) Gabor Orientation Image with Crack and Without Crack

The Gabor magnitude image and its phase or orientation image at 45° are shown in Fig. 4 (a), (c) and Fig. 4 (b), (d) respectively

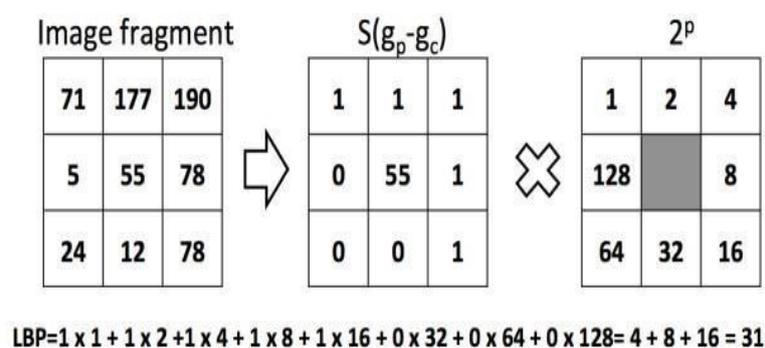
Figure. 5. Sample Test Image LBP Calculation

The steps necessary to get the LBP characteristic are detailed in Algorithm 2. To train a classifier, we feed it a picture of the Ancient Monument that has had its Gabor features removed.

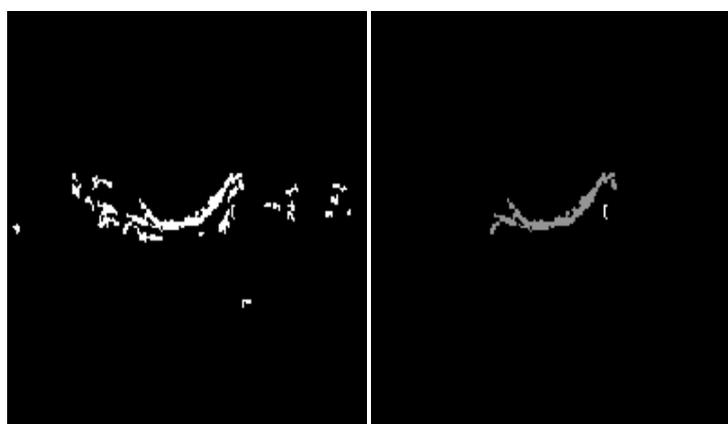
Figure 6. (a) Morphologically Processed Dilated Image (b) Eroded Image(c) Crack Segmented Image

Further, the cracks in the classifier image are detected using morphological operations. It produces dilation and erosion images, which subtracts the eroded image (Fig.6(b)) from the dilated image (Fig. 6(a)) to obtain the cracked regions in the classified image (Fig. 6(c)). The bounding box drawn over the cracked region for better identification.

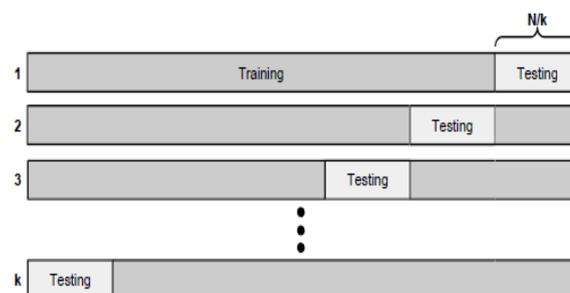
Figure 7. Illustration for k-fold Cross-Validation.

When using classification techniques, it is essential to keep the data used for training and testing separate so that the findings are not skewed. The k-fold cross-validation technique (shown in fig.7) is a well-known assessment strategy that uses many independent sets. A total of k evaluations are carried out on the picture once it has been folded into the specified number of folds, with each fold being put to use for testing while the remaining folds (k minus 1) are put to use for training. The example may be seen in the figure labelled. For the purpose of classifier assessment in this study, a 4-fold cross-validation approach is used. The picture dataset is split up into four sections, with each section containing 75 photos. The performance of the proposed crack detection system is evaluated with regard to ground truth pictures in terms of sensitivity, specificity, and accuracy.

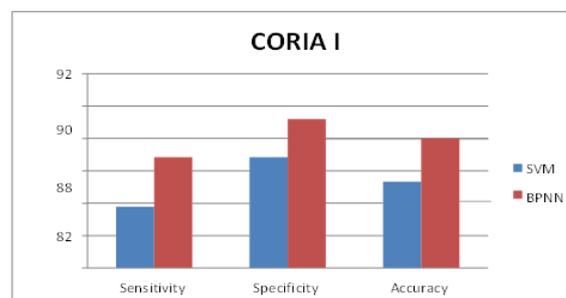
**Figure 9.** Performance comparison of AMCD I using SVM and BPNN

Fig. 9 shows the performance comparison of AMCD I using SVM and BPNN classifier. The Graph shows that AMCD I with BPNN performed better than AMCD I with SVM in terms of Sensitivity and Accuracy.

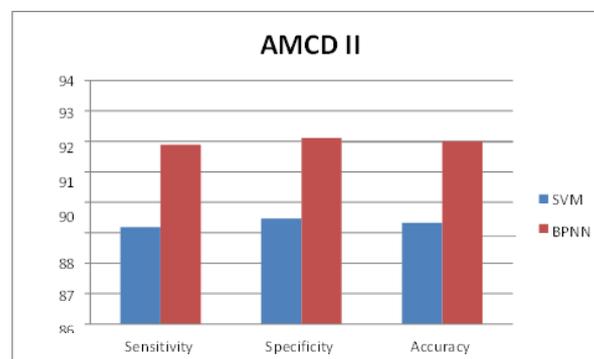
**Figure. 10** Performance comparison of AMCD II using SVM and BPNN

Fig. 10 shows the Performance Graphical comparison of AMCD II using SVM and BPNN classifier. The Graph shows that AMCD II with BPNN performed better than AMCD II with SVM in terms of Sensitivity, Specificity and Accuracy.

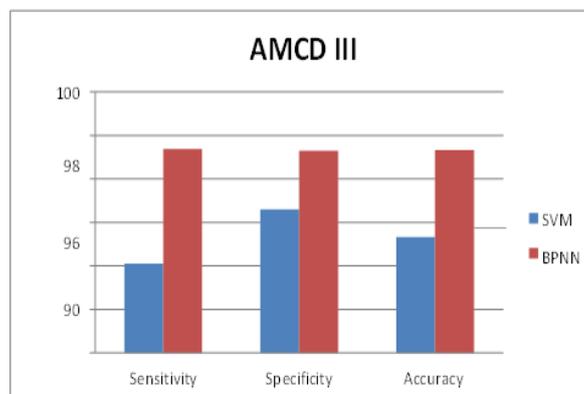
Fig. 11 Performance comparison of AMCD III using SVM and BPNN

Figure 11 presents a graphical comparison of the performance of AMCD III when utilising SVM and BPNN as the classifier. According to the graph, the AMCD III model trained with BPNN performed much better than the AMCD III model trained with SVM in terms of sensitivity, specificity, and accuracy.

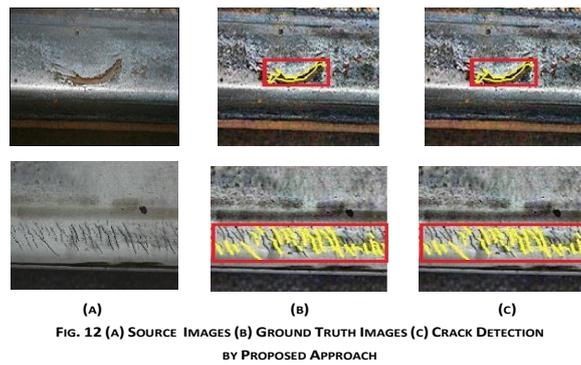
Fig. 12 (a) Source Images (b) Ground Truth Images (c) Crack Detection by Proposed Approach

The above description makes it abundantly evident that the combination of GLCM and LBP characteristics, which is referred to as AMCD III, results in excellent classification accuracy when used in conjunction with BPNN. The example categorization of a test picture using the suggested method AMCD III in conjunction with BPNN is shown in Figure 12.

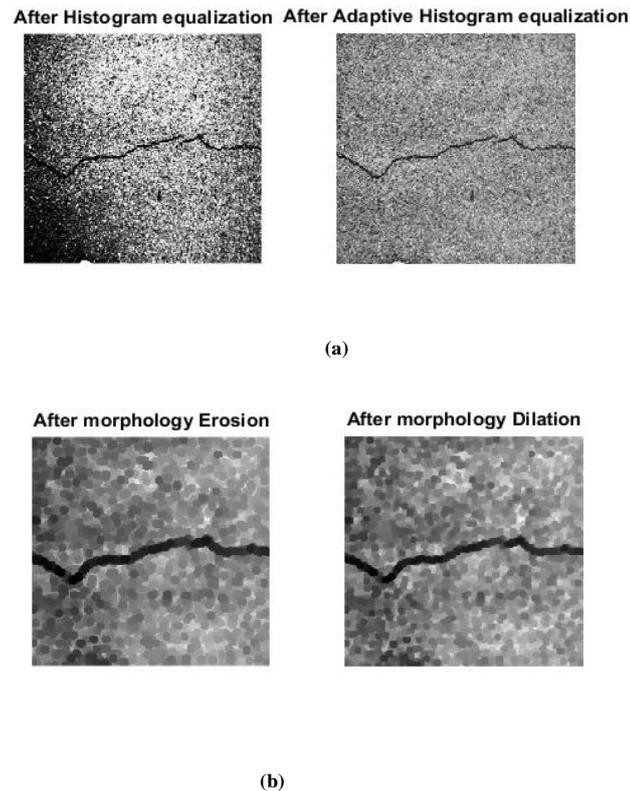
Fig. 13. GUI for Ancient Monument Crack Detection (a) Defective (b) non-Defective

Figure 13 depicts this in order to accomplish the aforementioned research goals, a user-friendly GUI was designed and built for automated crack detection.
