International Journal of BIM and Engineering Science

HBIM's Role in the Conservation and Restoration of Archaeological Buildings: Case Study: Omar Al-Khyam Hotel in Damascus

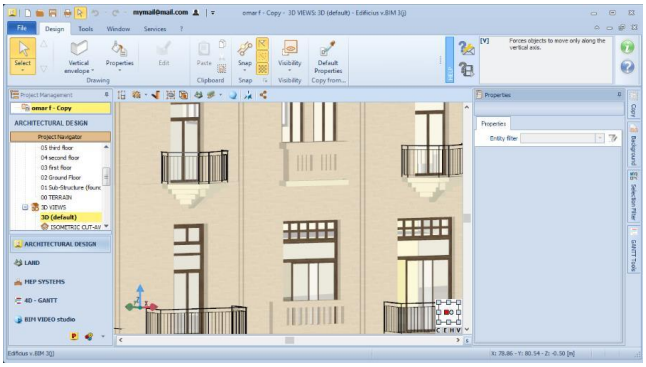
Figure 6. Corrosion analysis.

- **Corrosion:** Notable in the metal railings and window frames, primarily caused by prolonged exposure to moisture and lack of protective coatings (Figure 6).
- **Physical Damage:** Cracks and fractures were observed in walls and columns, likely resulting from aging materials and minor seismic activity (Figure 7).
- **Leakage:** Water stains and damp patches were identified, indicating deficiencies in the roofing and drainage systems (Figure 8).
- **Environmental Pollution:** Surface discoloration and biological growth, especially on stone surfaces, were linked to pollution from urban activities and nearby vegetation (Figure 9).

1. **Immediate Repairs**
   - Addressing severe corrosion in metal elements by applying anti-corrosion treatments.
   - Sealing cracks and fractures in load-bearing walls and columns using injection techniques.
